P. L. 93-251 SECTION 32 DEMONSTRATION  
PROJECTS STUDY

MRD HYDRAULIC LABORATORY SERIES  
REPORT NO. 8  
PRELIMINARY

PRELIMINARY LABORATORY INVESTIGATION  
OF SECTION 32 HARD POINT

U. S. ARMY ENGINEER DISTRICT, OMAHA  
MISSOURI RIVER DIVISION, OMAHA  
OCTOBER 1978

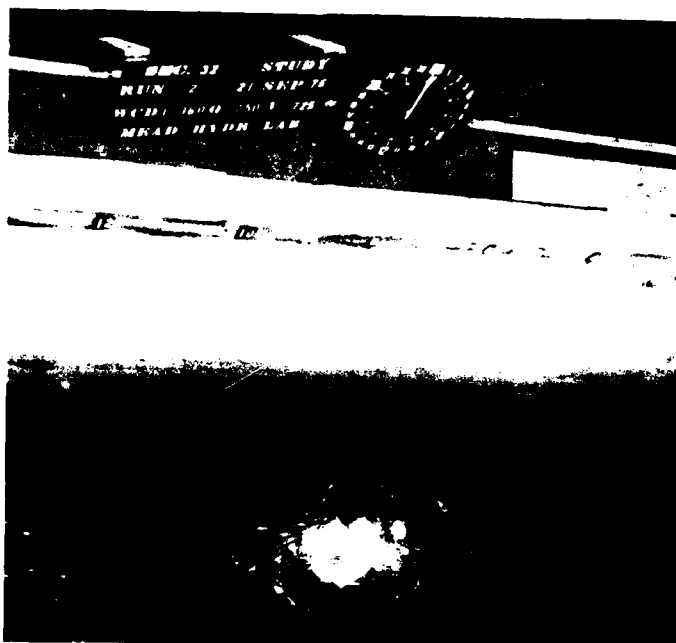
Photograph 4. Test bank arrangement prior to run 2. Notice that this run had no hard point structure.

Test run 2 had no hard point structures positioned in the right channel bank. This run was used to determine the amount of bank area which would be removed by erosion without any type of protection. At the upstream end of this run (station 1.7), the flow expanded off the end of the fixed rock revetted slope and caused the right bank erosion to extend to station 6.5. See photos 4 and 5 and plate 2. Station 6.0 was, therefore, selected as the location for the various hard point structures in the forthcoming model tests.

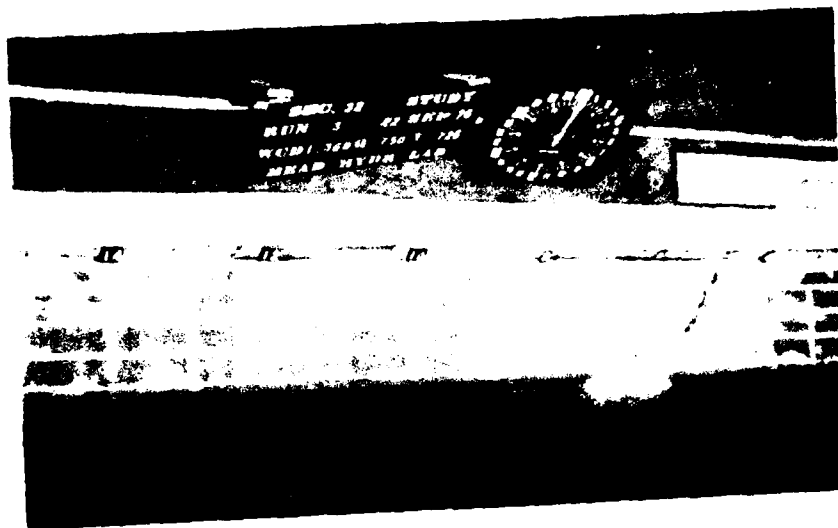
Photograph 6. Test bank arrangement prior to run 3.

The layouts of the different hard point structures are shown on plate 2 and in photographs 6 through 17. For test runs 3, 7, and 8, the hard point structures were constructed out to the edge of the channel bank. For test runs 4, 5, and 6, the hard point structures were extended 0.5 foot further into the channel. This was done in an attempt to determine if this would decrease the amount of bank erosion which occurred downstream from the hard point structures.

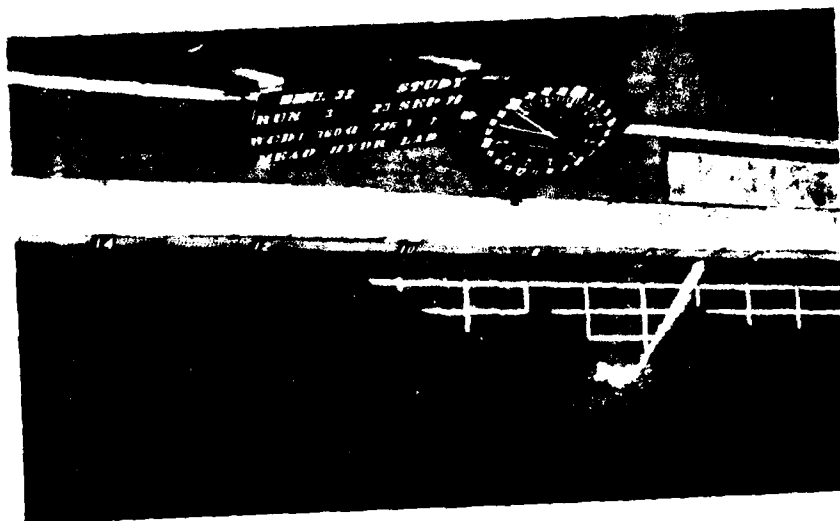
Photograph 7. Resulting channel bed and bank configurations at the end of run 3.

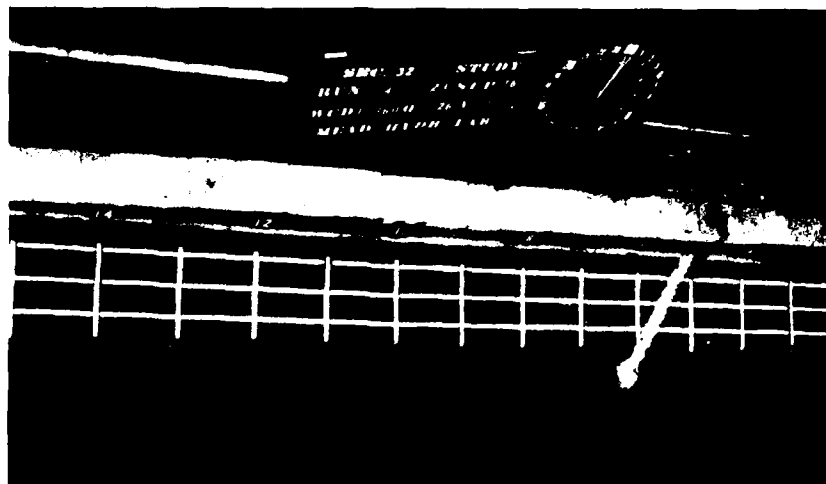
Photograph 8. Test bank arrangement prior to run 4.

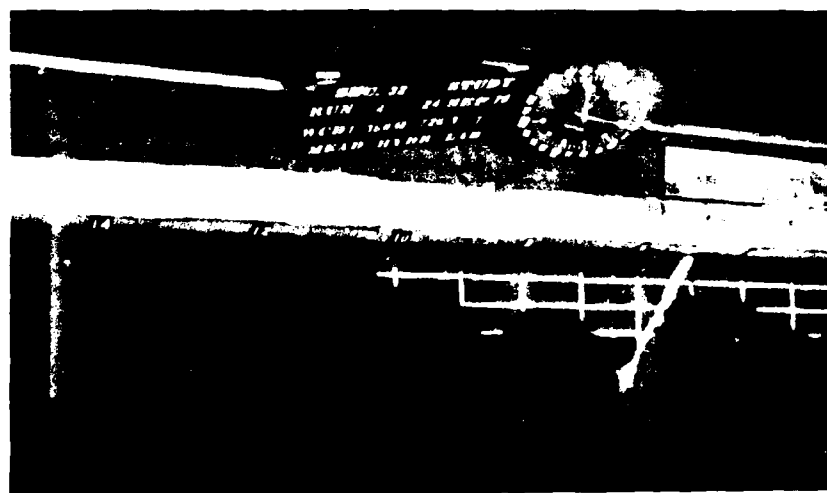
Photograph 9. Resulting channel bed and bank configurations at the end of run 4.

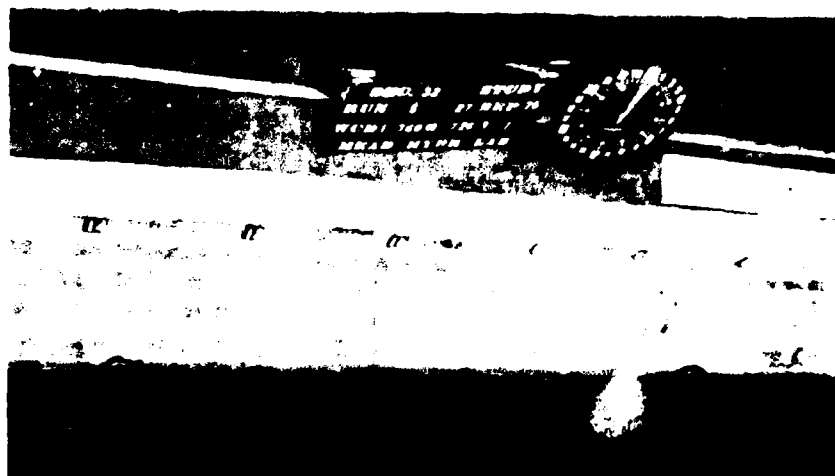
Photograph 10. Test bank arrangement prior to run 5.

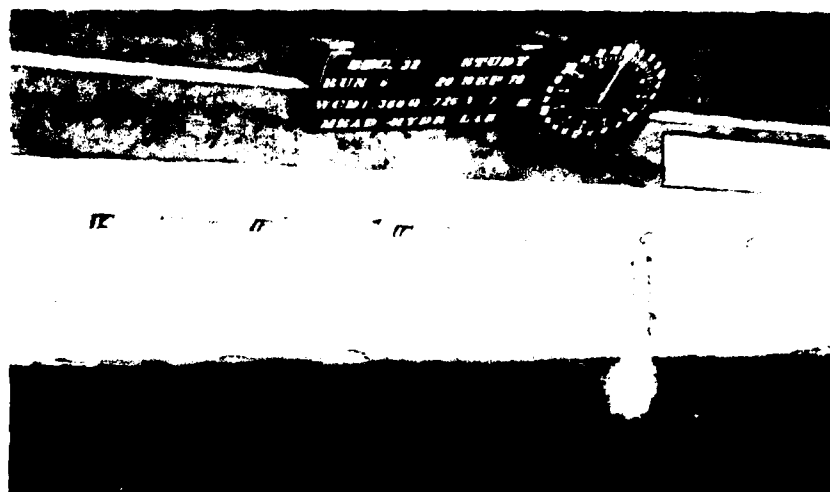
Photograph 12. Test bank arrangement prior to run 6.

The effect of the 0.5 foot riverward extension of a perpendicular root structure can be seen in the comparison of run 6 with run 7. The extension of the structure in run 6 protects more bank area downstream but uses a greater quantity of rock to armor the upstream slope of the hard point structure. The channel constriction caused by the hard point extension increases the channel velocities and, thus, results in a larger and deeper scour hole.

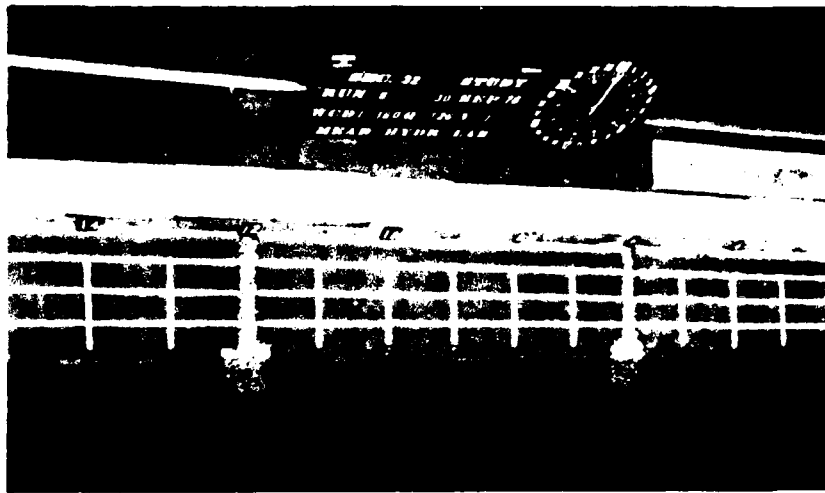
Photograph 16. Test bank arrangement prior to run 8.

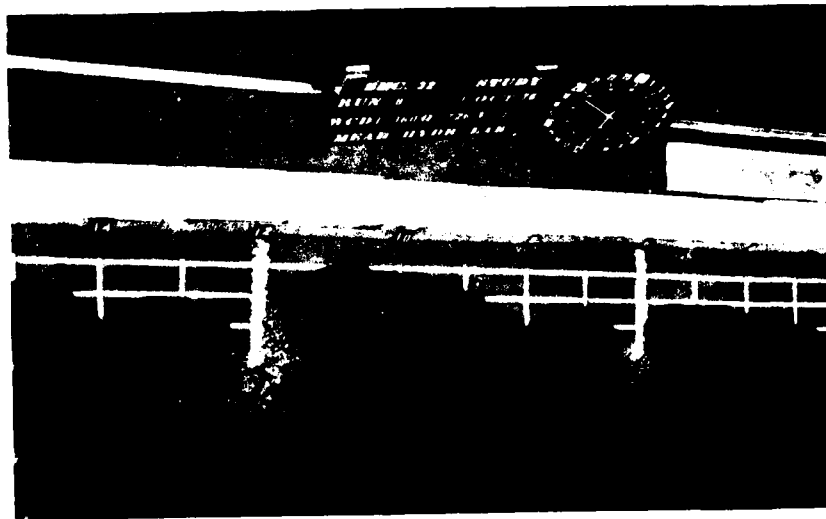
Photograph 17. Resulting channel bed and bank configurations at the end of run 8.

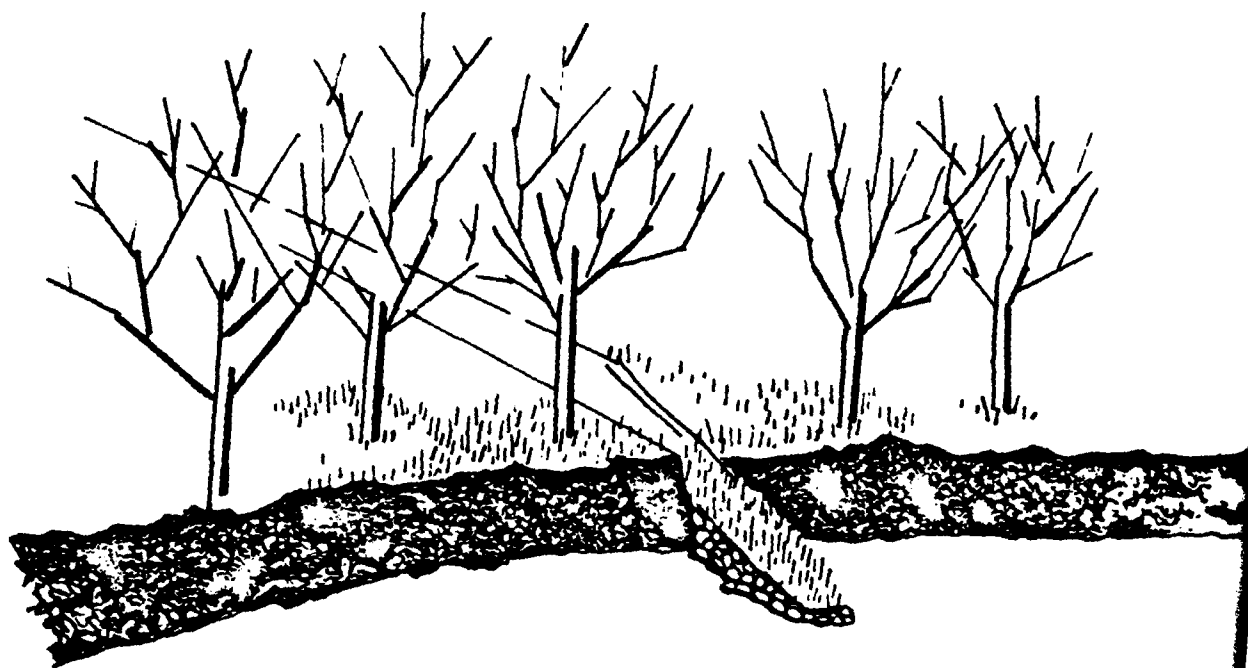
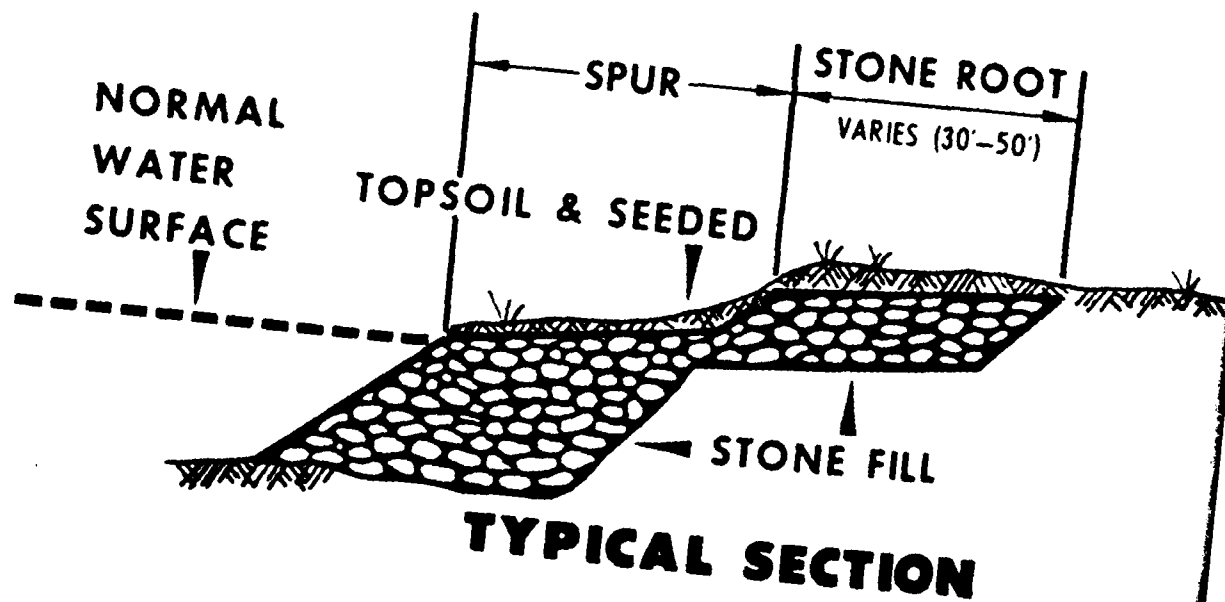
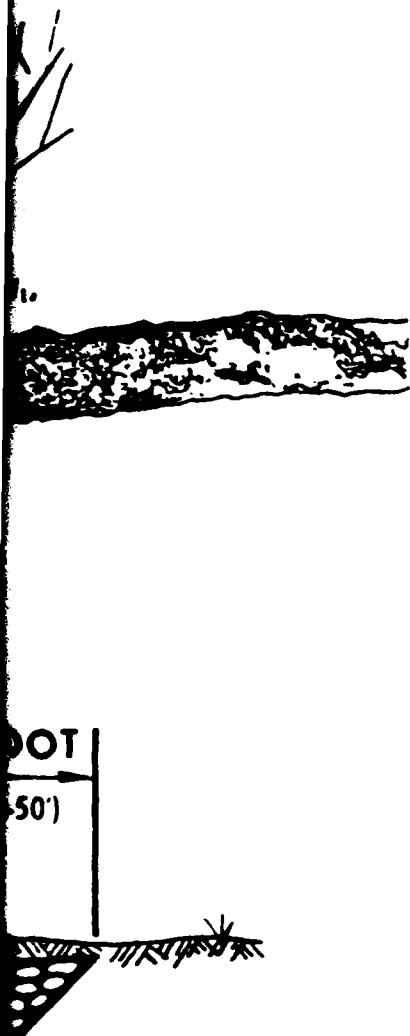
SECTION 32 DESIGN STUDY  
EROSION CONTROL USING HARD POINTS  
TYPICAL SECTION

Runs 3 through 8 (plate 2) indicate the amount of bank erosion, which occurred in run 2, was considerably reduced by a hard point structure located at station 6. Runs 4, 5, and 6 had more bank area saved than the other runs.

These runs had structures which extend 0.5 feet further riverward than the other runs. Of these three runs, the structures with angled roots had more bank area protected than the structure whose root was perpendicular to the channel bank. However, the angled root structures had more rock accumulated on the underwater slope than did the perpendicular root structure. See plate 2.

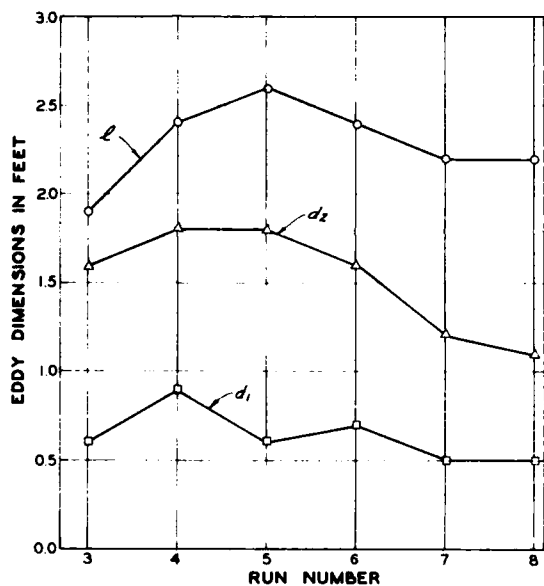
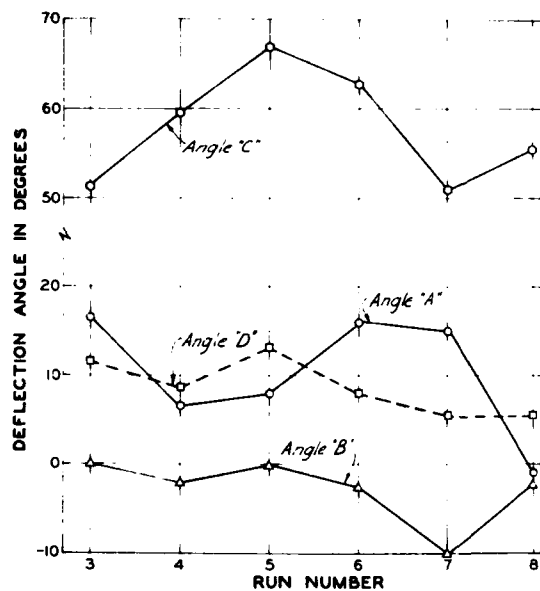
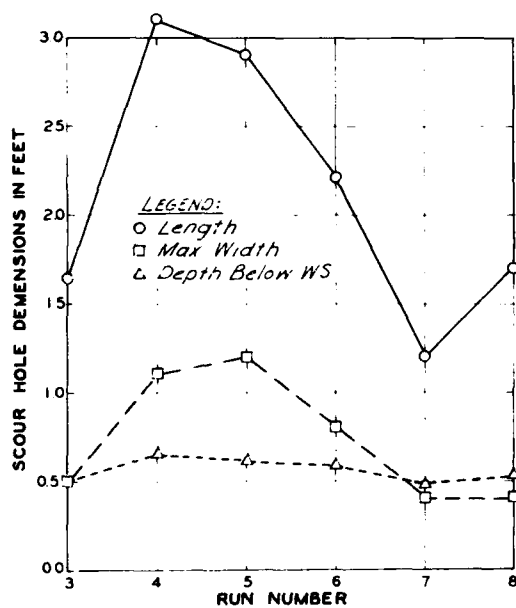
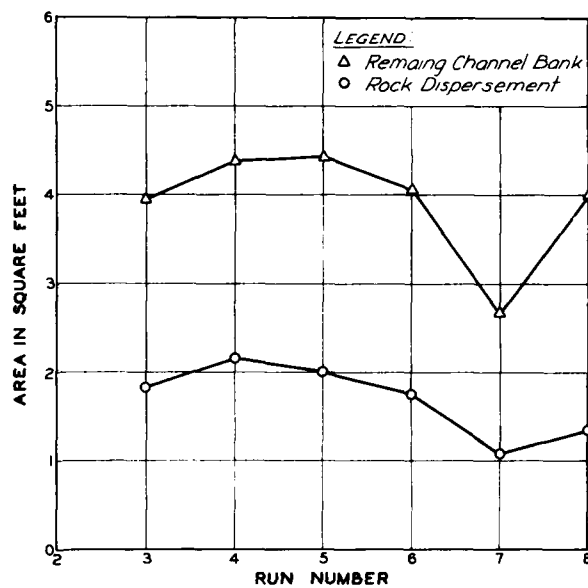
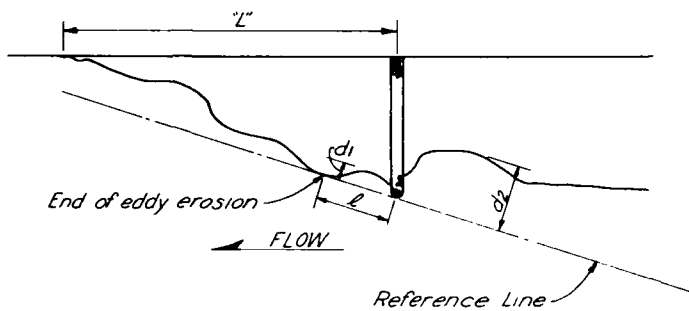
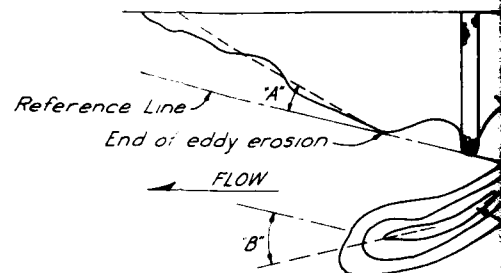
## SECTION 32 DESIGN STUDY **EROSION CONTROL USING HARD POINTS** **STRUCTURE EFFECTS ON LOCAL EROSION**

The channel maps are contour charts of the channel bed. Reproductions of the channel maps are not shown in this report. These contour charts showed the general channel characteristics of size and shape of bed scour and the structure effects on local erosion. The scour hole contour maps were extracted from the channel maps to show local effects of the hard point structures. See plate 2. The data which were extracted from the scour hole contour maps were plotted on graphs so as to detect changes and evaluate trends associated with the different structure variations. See plate 3.

The slow-motion portion of the time-lapse movie indicated that the eddy areas were larger when the structures were placed 0.5 feet further riverward from the channel bank. These structures also had larger and deeper scour holes associated with them. See plate 2. The larger scour holes were created by the increased channel velocities caused by the constriction of the channel from the longer hard point structures. These longer structures had more area of hard point structure exposed to the flow in the channel and, consequently, used a larger amount of riprap to protect the underwater slope. See plate 2. Plots of scour hole lengths, widths, and depths downstream from the ends of the hard point structures are shown on plate 3. The bank erosion line and scour hole angles are also shown on plate 3.
